DEPARTMENT OF TRANSPORTATION

Contract #: 04-0120F4Cty: SF/ALA Rte: 80 PM: 13.2/13.9File #: 69.28**WELDING INSPECTION REPORT****Resident Engineer:**Pursell, Gary**Address:** 333 Burma Road**City:** Oakland, CA 94607**Report No:** WIR-003171**Date Inspected:** 19-Jun-2008**Project Name:** SAS Superstructure**OSM Arrival Time:** 700**Prime Contractor:** American Bridge/Fluor Enterprises, a JV**OSM Departure Time:** 1700**Contractor:** Zhenhua Port Machinery Company, Ltd (ZPMC), Changxing Island **Location:** Shanghai, China**CWI Name:** Sun Wei**CWI Present:** Yes No**Inspected CWI report:** Yes No N/A**Rod Oven in Use:** Yes No N/A**Electrode to specification:** Yes No N/A**Weld Procedures Followed:** Yes No N/A**Qualified Welders:** Yes No N/A**Verified Joint Fit-up:** Yes No N/A**Approved Drawings:** Yes No N/A**Approved WPS:** Yes No N/A**Delayed / Cancelled:** Yes No N/A**Bridge No:** 34-0006**Component:** OBG**Summary of Items Observed:**

WELDING INSPECTION REPORT

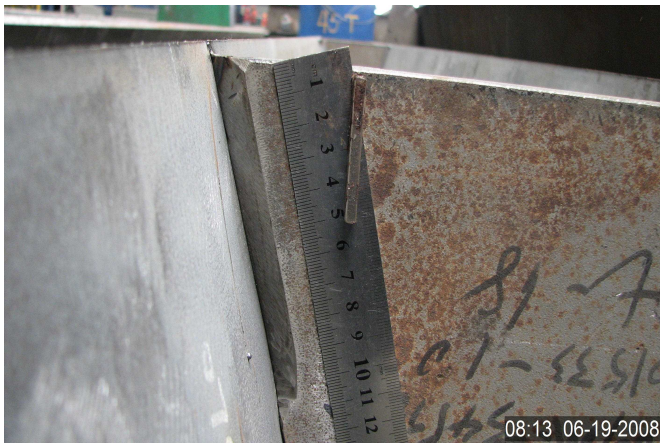
In general the root opening observed did not exceed 2 millimeters. The photograph below illustrates the continuity plates root opening not exceeding one millimeter.

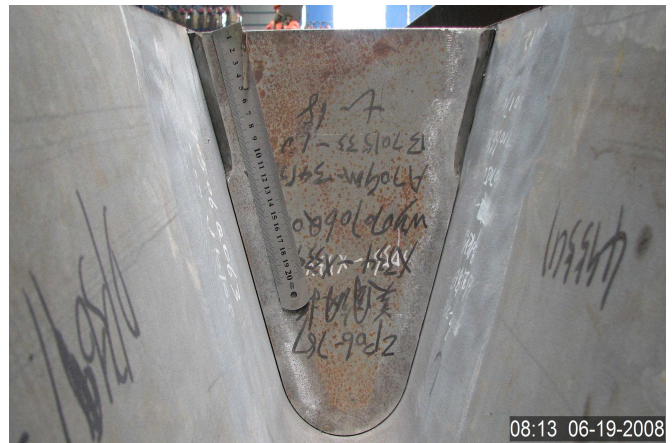
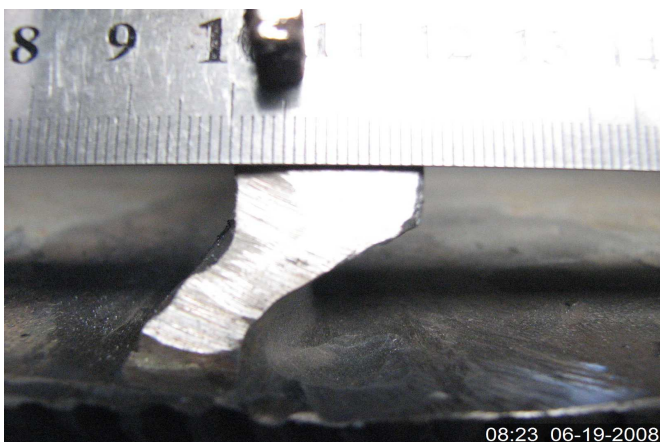
In addition, QA measured the depth of back gouge. The excavation was made by utilizing the air carbon arc process and grinder. The depth of the back gouge varies but in several instances QA observed the excavation to be the full thickness of the 18 mm plate. Below is a digital photograph illustrating the depth of excavation.
